Destructive Single-Event Failures in Diodes

Abstract—We examine single-event induced destructive failures in Schottky diodes. We first identified failures in DC-DC converters, and later confirmed their existence in independent diodes. The mechanism for failure along guard rings is also discussed.

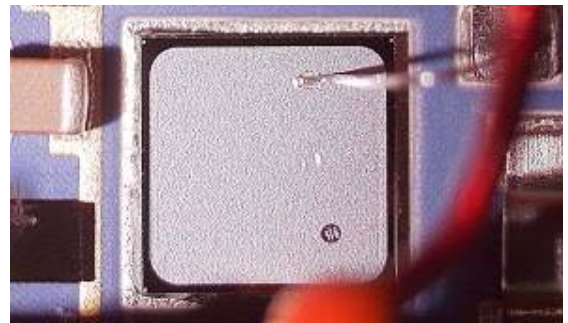
Fig. 1. The small dots are the locations where the metal melted due to the single-event in the (a) M3G2804R513R5TEM engineering model and in the (b) MTR28515 [1].

Previous work indicated that Schottky diode failures due to single-events [7] occur along the guard rings [8], which is where the MBR20200CT in the M3G2804R513R5TEM appear to fail as well. In [8], Ralston-Good shows that a short is formed between the guard ring and the n+ substrate of Schottky diodes when an ionizing radiation pulse is simulated. This short causes localized temperature rises from increased electric fields due to increased potential gradients over small areas. This increase in temperature causes the carrier concentration to increase exponentially, leading to a mesoplasma [9, 10] at the guard ring. A similar phenomenon could occur with the ion track from a heavy ion, shorting the guard ring and silicon substrate, leading to a mesoplasma at the guard ring.

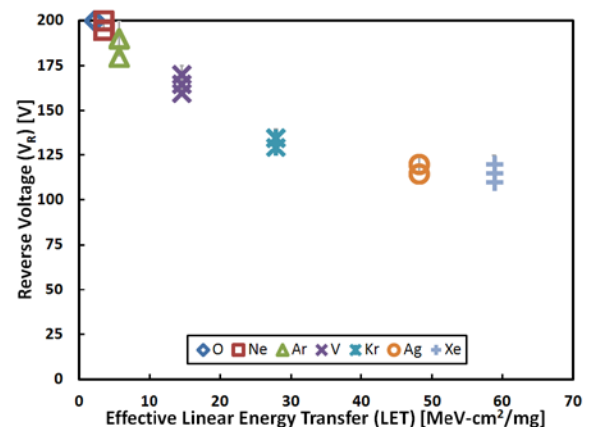
The ON Semi diodes were tested on four different occasions. It was quickly determined that, independent of the IR DC-DC converters, the diodes are, in fact, susceptible to destructive SEEs. EEE-INST-002 states that all diodes should be derated to 75% of rated voltage, so in theory, these diodes could be used up to a voltage of 150 V. Figure 3 shows the last reverse voltage value at which the diode was biased before it suffered a destructive failure. The parts irradiated with 508 MeV V (here V is for Vanadium, rather than voltage) failed at voltages slightly greater than 150 V. The parts irradiated with 1032 MeV Kr, however, failed considerably below the 75% of rated voltage threshold. Fortunately, Kr is above the iron knee in the galactic cosmic ray linear energy transfer spectrum, so the abundance in space is lower, which will reduce the failure rate.

Additionally, the last passing voltage appears to bottom out around Ag, as it has roughly the same last passing and failure voltages as Xe. A similar phenomenon has been described by S. Liu, *et al.*, in power MOSFETs [11]. The authors showed that a minimum field must be applied for power MOSFETs to be susceptible to single-event burnout. Ordinarily, the minimum drain voltage required for failure decreases with increasing atomic mass or increasing ion LET; however, when below the minimum field required for burnout, heavier ions no longer fail at a lower voltage than

Fig. 3. The last voltage at which an ON Semiconductor MBR20200CT diode was irradiated without destructive failure. The error bars (many of which are smaller than the symbols) indicate the voltage at which the part did fail.

their lighter counterparts. Instead, the minimum failure drain voltage reaches an asymptote, and remains constant even when irradiated with heavier ions. This appears to be occurring in the diodes as well.

In this summary, we have shown that diodes are susceptible to destructive single-event effects, and that these failures occur along the guard ring. By determining the last passing voltages, a safe operating area can be derived. By derating off of those values, rather than by the rated voltage, like what is currently done with power MOSFETs, we can work to ensure the safety of future missions.

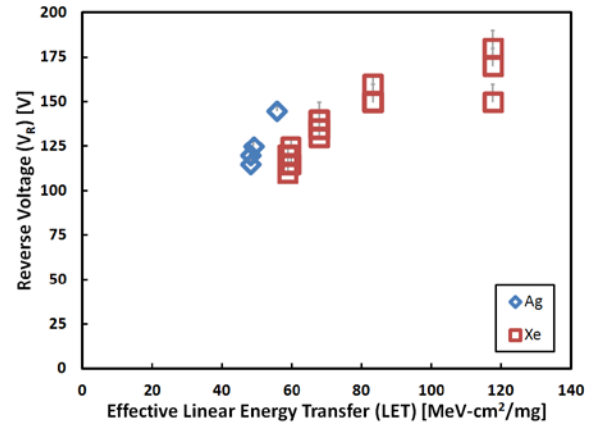
All data presented to this point have been at normal incidence. Figure 4 shows the last passing reverse voltage as a function of effective LET. The angles investigated with Ag were 10° and 30°, while with Xe, the parts were irradiated at angles of 10°, 30°, 45°, and 60°. The 0° data in this figure are the Ag and Xe data included in Figure 3. Surprisingly, the last passing voltage does not improve with angle as quickly as might be expected. This is illustrated in Figure 5, where the last passing voltage is plotted as function of angle, rather than LET, for Ag and Xe. The data up to and including the 45° points follow the cosine law, as expected; however, the 60° points make the trend much more linear in appearance. This is likely due to the large charge collection volume inherent in diodes. Unlike CMOS, where the collection volume is limited solely to the channel, the collection volume is really the entire silicon cathode. As a result, the volume through which the ion track deposits charge does not decrease with the same severity at angle as it does through the small channels of MOSFETs.

Fig. 4. The symbols indicate the last voltage at which an ON Semiconductor MBR20200CT diode passed. This figure only includes data from ions taken at angle. The 0° degree points are included as well and can also be found in Figure 3.

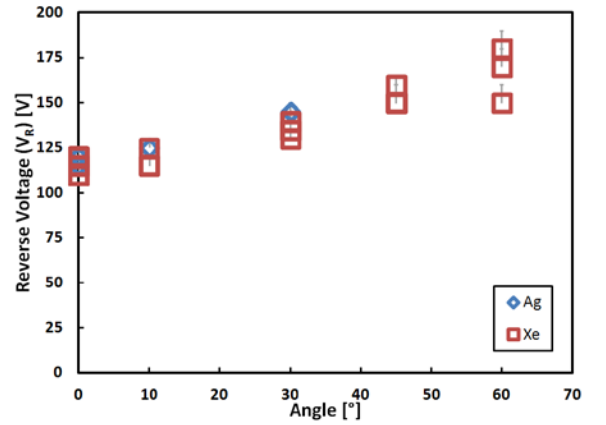
Fig. 5. Last passing reverse voltage as a function of angle for Ag and Xe irradiations of ON Semi MBR20200CT diodes. The charge collection volume does not change drastically with angle, hence, the last passing voltage also does not change quickly.

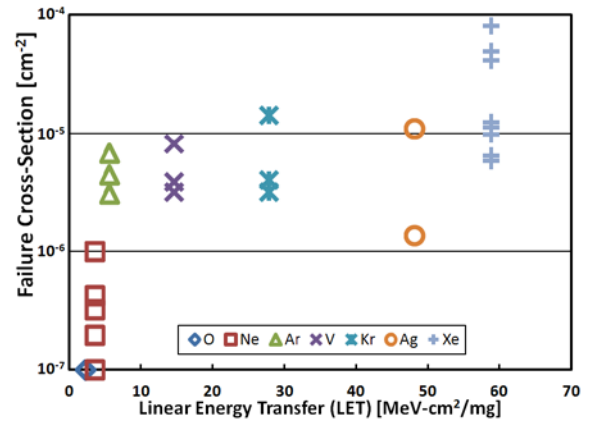
While it is difficult to accurately calculate destructive SEE cross-sections due to the delays associated with stopping the beam after the error has occurred, Figure 6 shows the failure cross-section as a function of Linear Energy Transfer (LET). The data have a clear onset threshold; no failures were observed with 183 MeV O (LET = 2.19 MeV-cm²/mg), but they did occur at 195 V and 200 V with 216 MeV Ne (LET = 3.49 MeV-cm²/mg). The cross-section values associated with O are plotted as an upperbound by simply taking the inverse of the fluence at the last passing voltage, which was the rated voltage of the diode, 200 V_m because no failures were observed at this point.

Fig. 6. Failure cross-section as a function of LET for the MBR20200CT diode.

These values were calculated using CRÈME-MC with an onset LET of 3.49 MeV-cm²/mg and a saturated cross-section of 10⁻⁵ cm⁻², based roughly on the average of the Xe cross-section values as found in Figure 4. Based on the sheer number of diodes flying on a given spacecraft and the length of NASA missions, single-event-induced diode failures could become a serious issue.
